LateralX Machines: Beeping and electronic clicking noises ID: 13935.1

Follow this troubleshooting guide to help resolve noise issues on the BowFlex LateralX LX3, LX5, and LX5+. Please note there will be general mechanical noises present during workouts due to the complicated nature of the machine. These noises can become more noticeable or increase at higher speeds and/or wider stride widths (LX5, LX5+ models only).

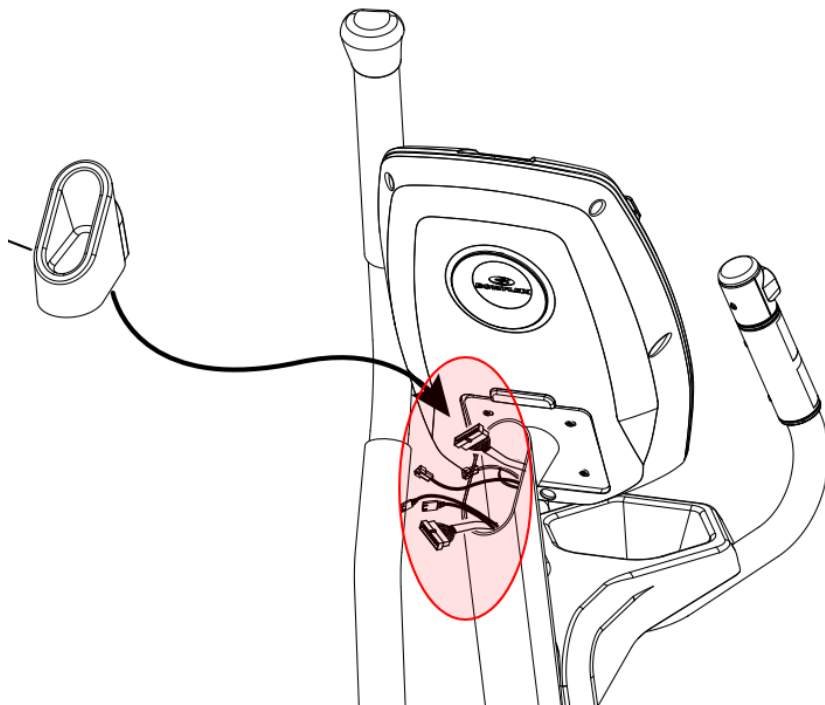
(Reference 1)

Inspect and reseat the cables located under the console mast end cap.

1. Remove the console mast end cap and inspect the static handlebar cable connection (**reference 1**). Unplug and inspect the cable and connectors for damage, such as crimps, cuts, or bent pins. If the cable is undamaged, plug it back in and retest your machine [\[13935.C\]](#). If the issue persists, [order a Console \[13935.B\]](#)
