Max Trainer Max Total: My machine is making a clicking, clunking, or knocking noise

ID: 13752.3

Follow this troubleshooting guide to help resolve the cause of noise issues on the Max Trainer Max Total.

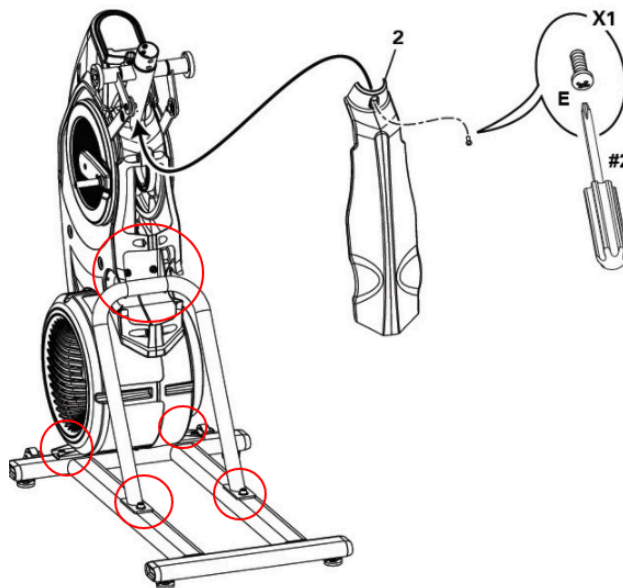
(Reference 2)

Remove the rear shroud as indicated in this image. The bolts to remove are circled in red.

- 2. If the noise is coming from any other area, tighten all hardware on your machine. Use a Phillips head screwdriver to remove the rear shroud. Tighten the 4 bolts connecting the rail assembly to the frame and the 4 large bolts on the base assembly (**reference 2**) [\[13752.B\]](#).

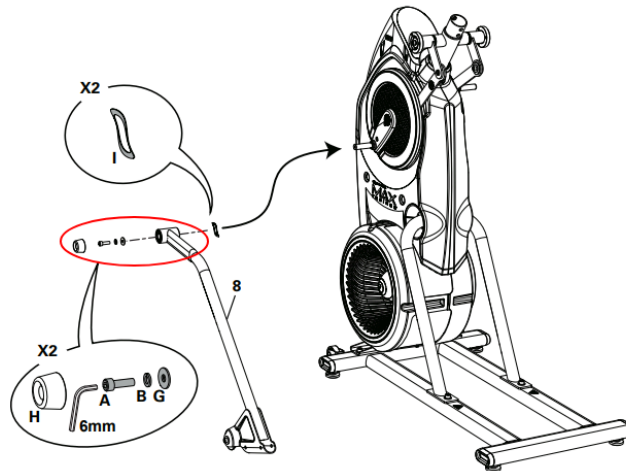
(Reference 3)

The Wave Washers are the part labeled 'I' in this image. These should be installed between the crank arm and the pedal arm (8).

3. If the noise persists, listen to the pedal area near the foot pedals. If the noise originates from the pedal area, please visit [Max Trainer Max Total: The pedals are making a noise or not staying on track](#) to continue troubleshooting.
4. **If the noise is coming from the bottom of the machine**, check the fan area again for obstructions. Remove any debris that may block fan movement [\[13752.C\]](#). If the noise persists, please visit [Max Trainer Max Total: My machine is making a metallic grinding or scraping noise](#) to continue troubleshooting.
5. **If the noise is coming from the top of the machine**, check if the wave washers have been installed (**reference 3**). If they are not installed, [order a Wave Washer Kit \[13752.D\]](#).

- It is normal for the pedal arm to slide back and forth slightly where it connects to the crank arm.
- This motion is critical for proper machine function - the wave washer acts as a cushion to soften the movement.
- Do not install more than one wave washer per pedal arm, as this will reduce its effectiveness.

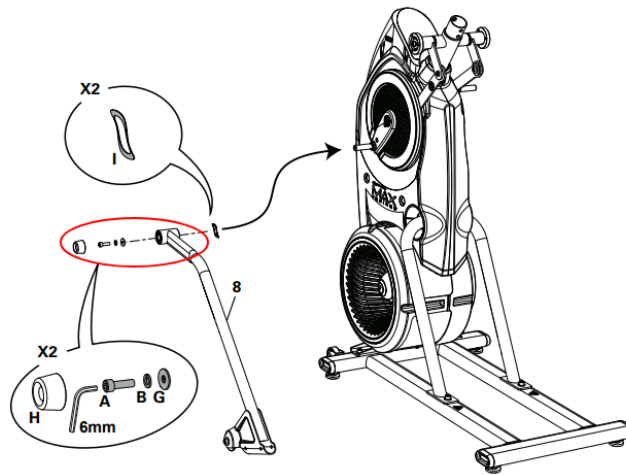
(Reference 4)

The cap is the part labeled 'H' in this image. Remove the cap and loosen the screw (A) using a 6mm Allen wrench. Remove the pedal arm (8). Repeat to remove the second pedal arm. Reinstall each pedal arm on the opposite side and test for the noise.

8. If the noise has been reduced and the noise still originates from the upper area of the machine, swap the pedal arms to the opposite side (**reference 4**) and listen for the noise. To remove the pedal arms, remove the caps from the crank arm. Remove the bolt using a 6mm Allen wrench, then remove the pedal arm from the machine. Repeat to remove the other pedal arm, then reinstall each pedal arm on the opposite side. Manipulate the pedals for several rotations, listening for the noise. If the noise remained on the original side, [order a Crank Arm \[13752.G\]](#). If you were unable to remove a pedal arm during this process, [order a Pedal Arm and Crank Cover](#) as well [\[13752.H\]](#). If the noise switched sides with the pedal arm, [order a Pedal Arm \[13752.I\]](#).
