# Max Trainer M8: My machine is making a clicking, clunking, or knocking noise

ID: 13736.2

Follow this troubleshooting guide to help resolve the cause of noise issues on the Max Trainer M8.

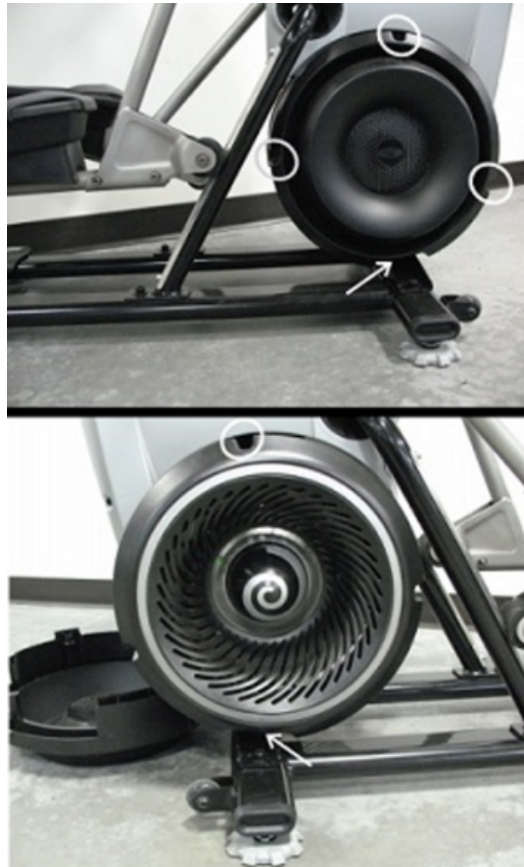
(Reference 1)

The top image indicates the locations of the screws for the lower right fan cover. Remove the screws in the white circles and loosen the screw at the white arrow. Unplug the power inlet wire and then remove the cover.  
The bottom image indicates the locations of the screws for the lower left fan cover.

2. **If the noise originates from the fan area**, check for any obstructions. Using a Phillips head screwdriver, remove the screws from the lower right and lower left fan covers (**reference 1**). Watch the video below for instructions on removing the lower right fan shroud. Remove the fan covers and inspect the fan area for any objects that may be obstructing fan movement. Remove any obstructions, if present [\[13736.A\]](#). If the noise persists in the fan area, please visit [Max Trainer M8: My machine is making a metallic grinding or scraping noise](#) to continue troubleshooting.

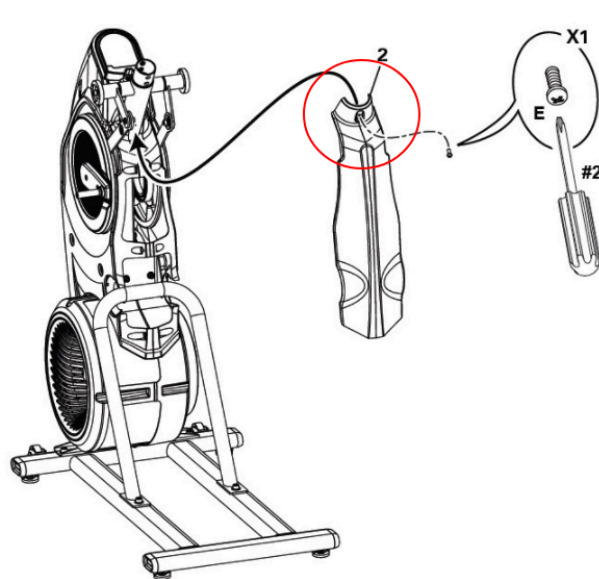
**(Reference 2)**

The screw to remove is circled in red. Once removed, the rear shroud can be removed as well.

3. If the noise persists, remove the rear shroud from your machine using a Phillips head screwdriver (**reference 2**), then tighten all bolts on your machine. Using an Allen wrench, tighten the 4 bolts connecting the top of the rail assembly to the frame (**reference 3**), then tighten the 4 bolts on the base assembly (**reference 4**) [[13736.B](#)].

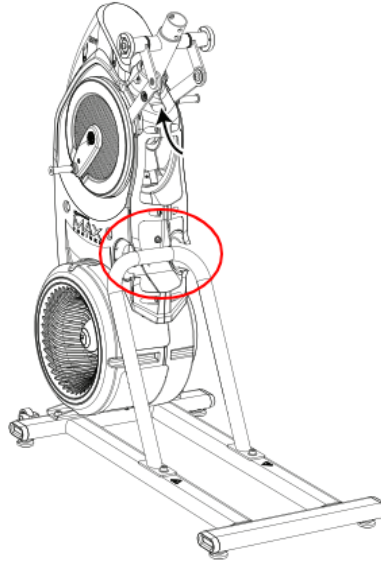
**(Reference 3)**

The red circle in the center of this image indicates the location of the first 4 bolts to tighten on the rail assembly and frame.

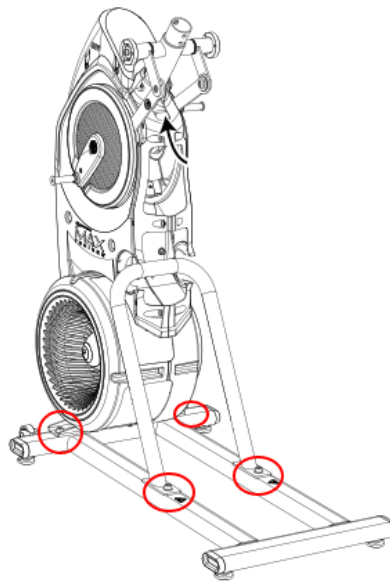
**(Reference 4)**

The red circles in this image indicate the location of the 4 larger bolts to tighten on the base assembly.

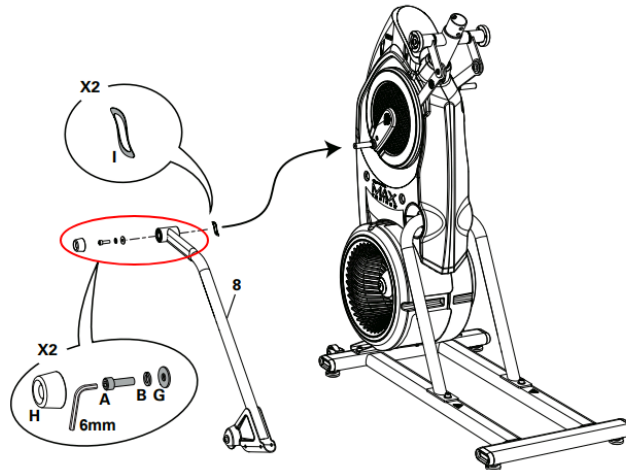
**(Reference 5)**

The Wave Washers are the part labeled 'I' in this image. These should be installed between the crank arm and the pedal arm (8).

4. If the noise persists, listen to the pedal area near the foot pedals. If the noise originates from the pedal area, please visit [Max Trainer M8: The pedals are making a noise or not staying on track](#) to continue troubleshooting.
5. **If the noise is coming from the bottom of the machine**, check the fan area again for obstructions. Remove any debris that may block fan movement [\[13736.C\]](#). If the noise persists, please visit [Max Trainer M8: My machine is making a metallic grinding or scraping noise](#) to continue troubleshooting.
6. **If the noise is coming from the top of the machine**, check if the wave washers have been installed (**reference 5**). If they are not installed, [order a Wave Washer Kit \[13736.D\]](#).

- It is normal for the pedal arm to slide back and forth slightly where it connects to the crank arm.
- This motion is critical for proper machine function - the wave washer acts as a cushion to soften the movement.
- Do not install more than one wave washer per pedal arm, as this will reduce its effectiveness.

- If the wave washers are installed, tighten the crank nut on each crank arm. Remove the covers on the crank arms and tighten each crank nut using a 14mm socket wrench. Please note, there will be grease on the crank arms. Once tightened, manipulate the pedals for several rotations, then check if the crank nuts remained tightened [\[13736.E\]](#). If the crank nut continues to come loose, [order an Engine \[13736.F\]](#).

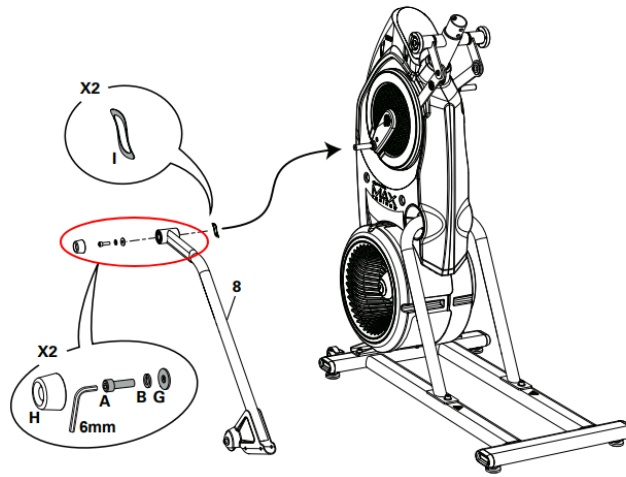
**(Reference 6)**

The cap is the part labeled 'H' in this image. Remove the cap and loosen the screw (A) using a 6mm Allen wrench. Remove the pedal arm (8). Repeat to remove the second pedal arm. Reinstall each pedal arm on the opposite side and test for the noise.

- If the noise was not reduced or eliminated, please visit [Max Trainer M8: Upper Pulley Issues](#) to troubleshoot further.
- If the noise has been reduced and the noise still originates from the upper area of the machine, swap the pedal arms to the opposite side (**reference 6**) and listen for the noise. To remove the pedal arms, remove the caps from the crank arm. Remove the bolt using a 6mm Allen wrench, then remove the pedal arm from the machine. Repeat to remove the other pedal arm, then reinstall each pedal arm on the opposite side. Manipulate the pedals for several rotations, listening for the noise. If the noise remained on the original side, [order a Crank Arm \[13736.G\]](#). If you were unable to remove a pedal arm during this process, [order a Pedal Arm and Crank Cover](#) as well [\[13736.H\]](#). If the noise switched sides with the pedal arm, [order a Pedal Arm \[13736.I\]](#).
